# Manhole Inspection Summary

Manhole # S25EE\_023MH

Insp Date: **10/17/07 8:33 AM**

**Location** Address: **1157 WINCHESTER ST**

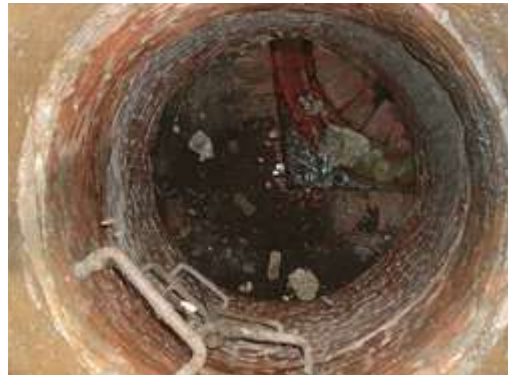
Top View

Evidence of surcharge - Bench debris.  
Channel debris.

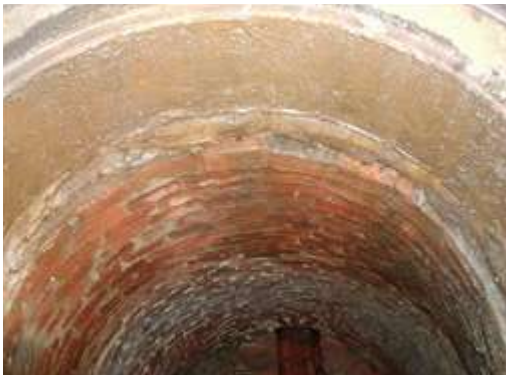
Defect

Frame leaks. Adjustment deterioration  
and infiltration. Barrel infiltration - other  
side.

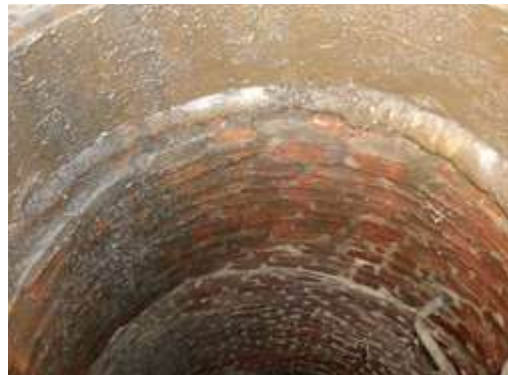
Defect

Frame leaks. Adjustment deterioration  
and infiltration. Barrel infiltration.

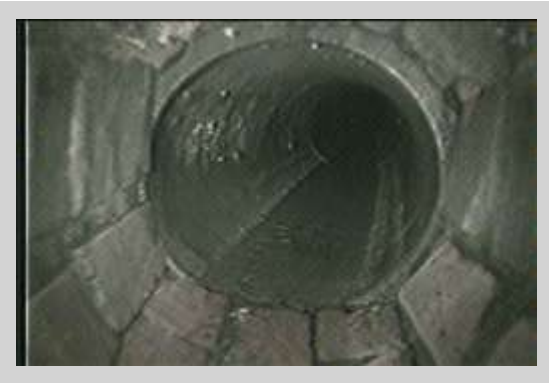
### 8 in. Circular Gravity Sewer Pipe Out @ 12 O'Clock

Infiltration: **Evidence** Pipe Seal Cond: **Cracked**

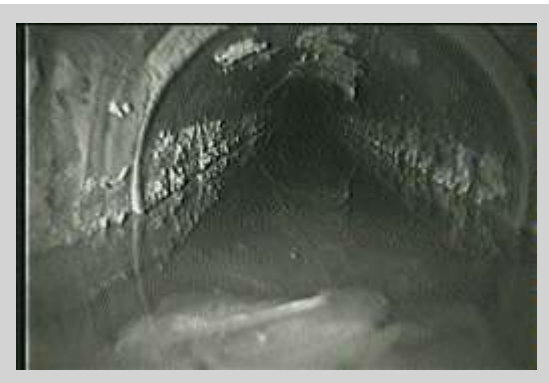
### 8 in. Circular Gravity Sewer Pipe In @ 3 O'Clock

Deposits: ☐ None ☐ Mud ☐ Sludge ☒ Debris ☒ Grease

Silt Depth: **0** (in.) Deposits Extent: **Light**
